Photo Log

Stony Ford Road – Ford Farms

by Andreescu, Stephanie

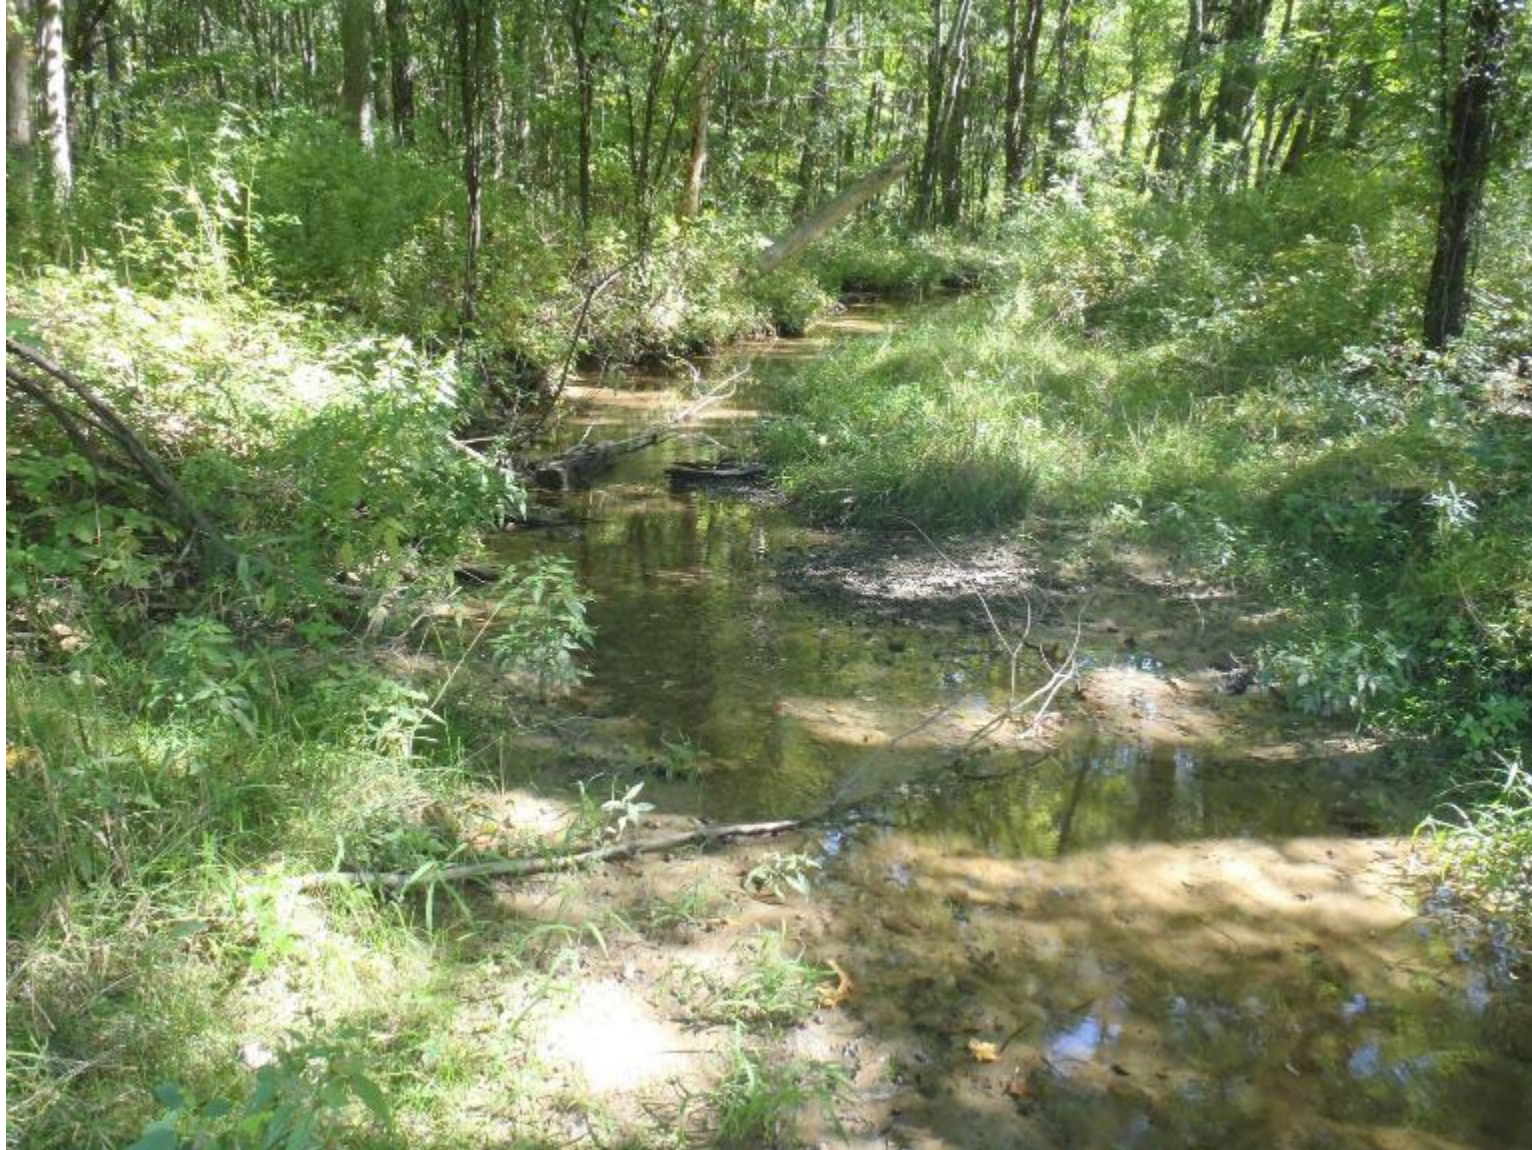
P9220027 – Downstream of Site, Looking Downstream

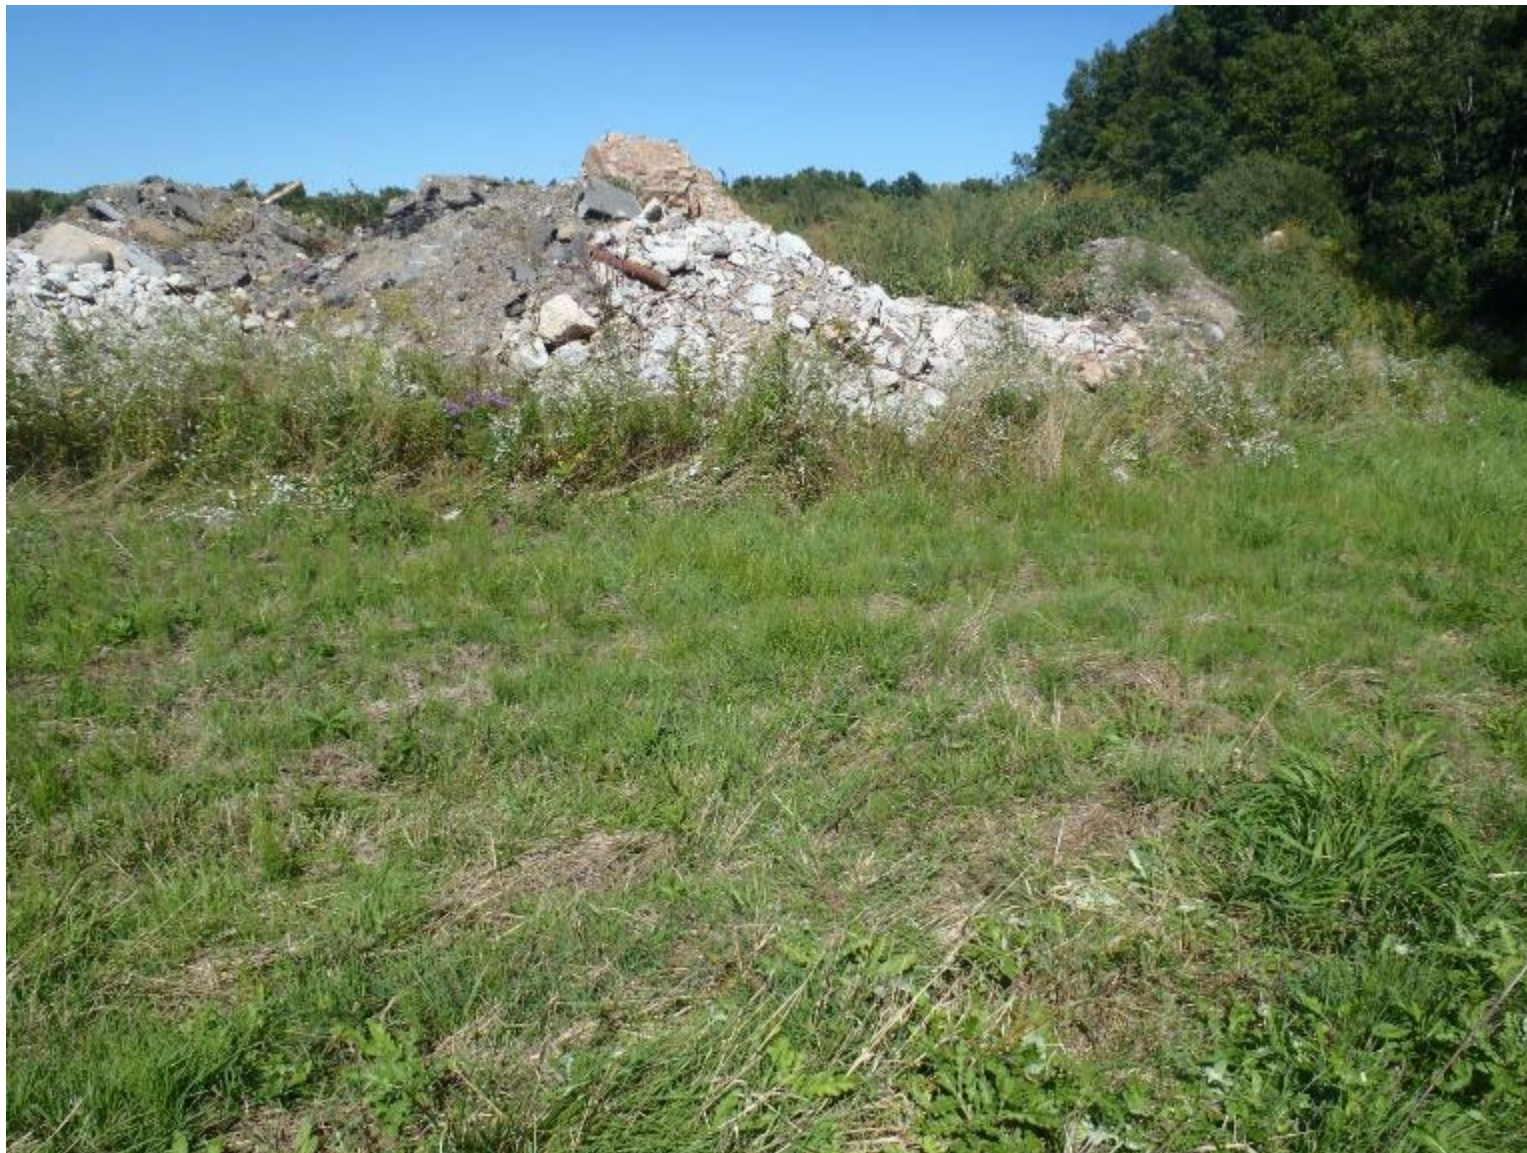
P9220028 – Potential Wetland Fill
